HEAD-TO-HEAD COMPARISON USING PAVEMENT DAMAGE ASSESSMENT DATA

EMC SQUARED SYSTEM STABILIZER PRODUCTS VERSUS CALCIUM-BASED STABILIZER PRODUCTS IH 635 EAST BOUND AND WEST BOUND FRONTAGE ROADS BETWEEN BELT LINE ROAD NORTH AND MACARTHUR BOULEVARD NORTH

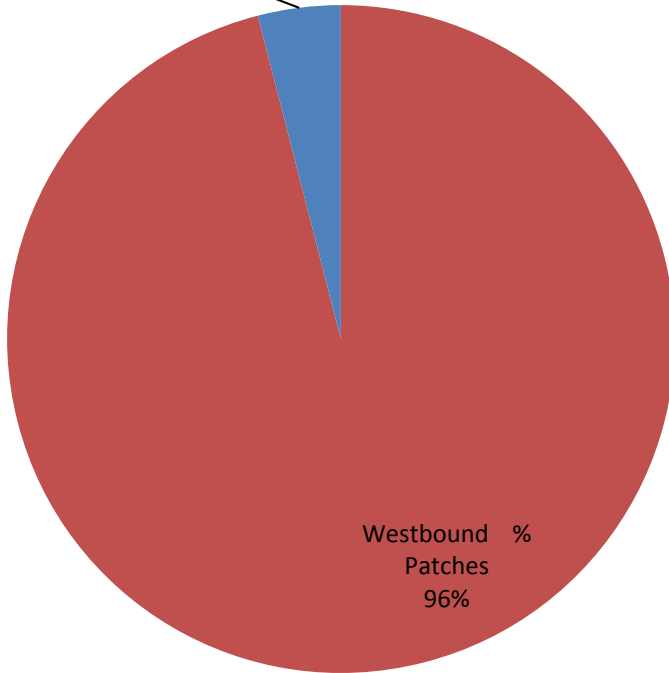
COMPARING TOTAL AREA OF PATCH REPAIRS IN SQ FT. IH 635 FRONTAGE ROADS

Eastbound
% Patches
4%

Westbound %
Patches
96%

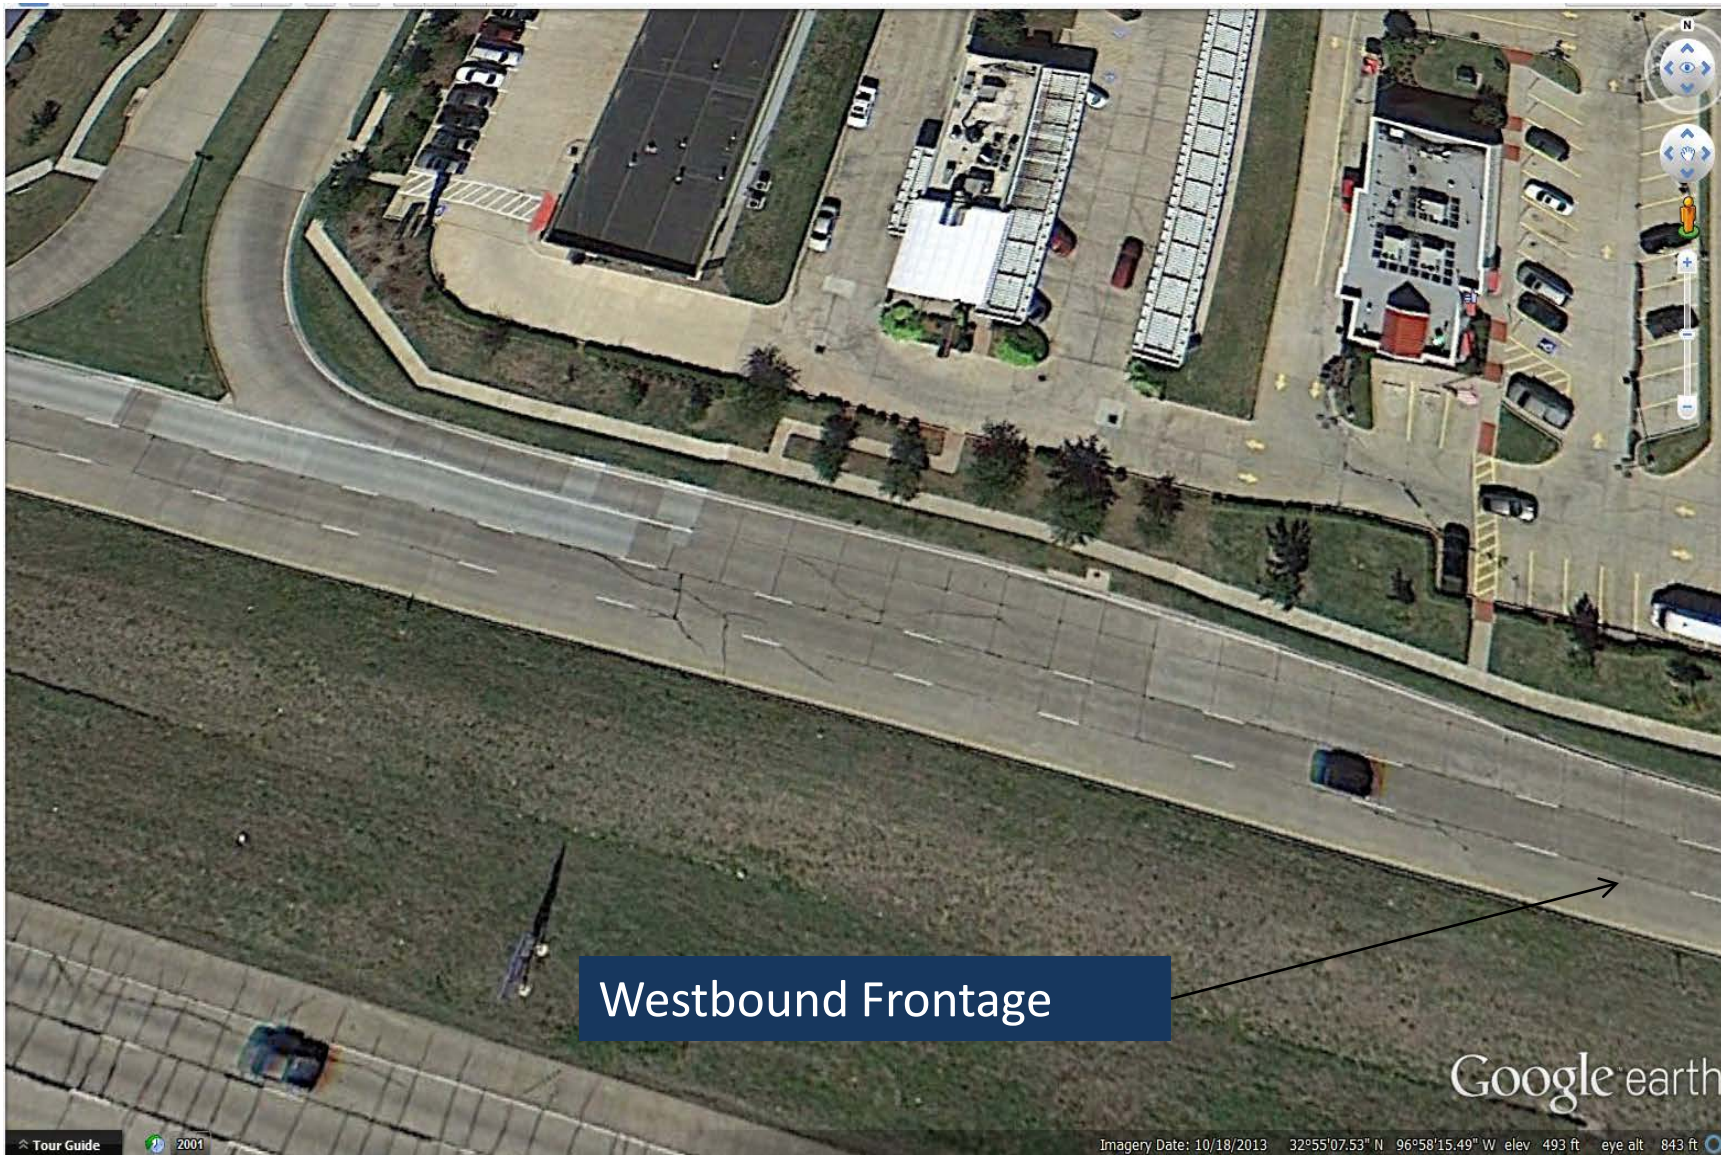
3 total patches (occupying 70% of total length of frontage road)

All patches are >2000 sq. ft. in size (average of all three =12,740 sq. ft. in size)

Four cracks extend outward from the edge of largest patch

Close-up of Westbound I-635 Frontage Road Damage
