HEAD-TO-HEAD COMPARISON USING PAVEMENT DAMAGE ASSESSMENT DATA

EMC SQUARED SYSTEM STABILIZER PRODUCTS VERSUS CALCIUM-BASED STABILIZER PRODUCTS IH 635 EAST BOUND AND WEST BOUND FRONTAGE ROADS BETWEEN BELT LINE ROAD NORTH AND MACARTHUR BOULEVARD NORTH

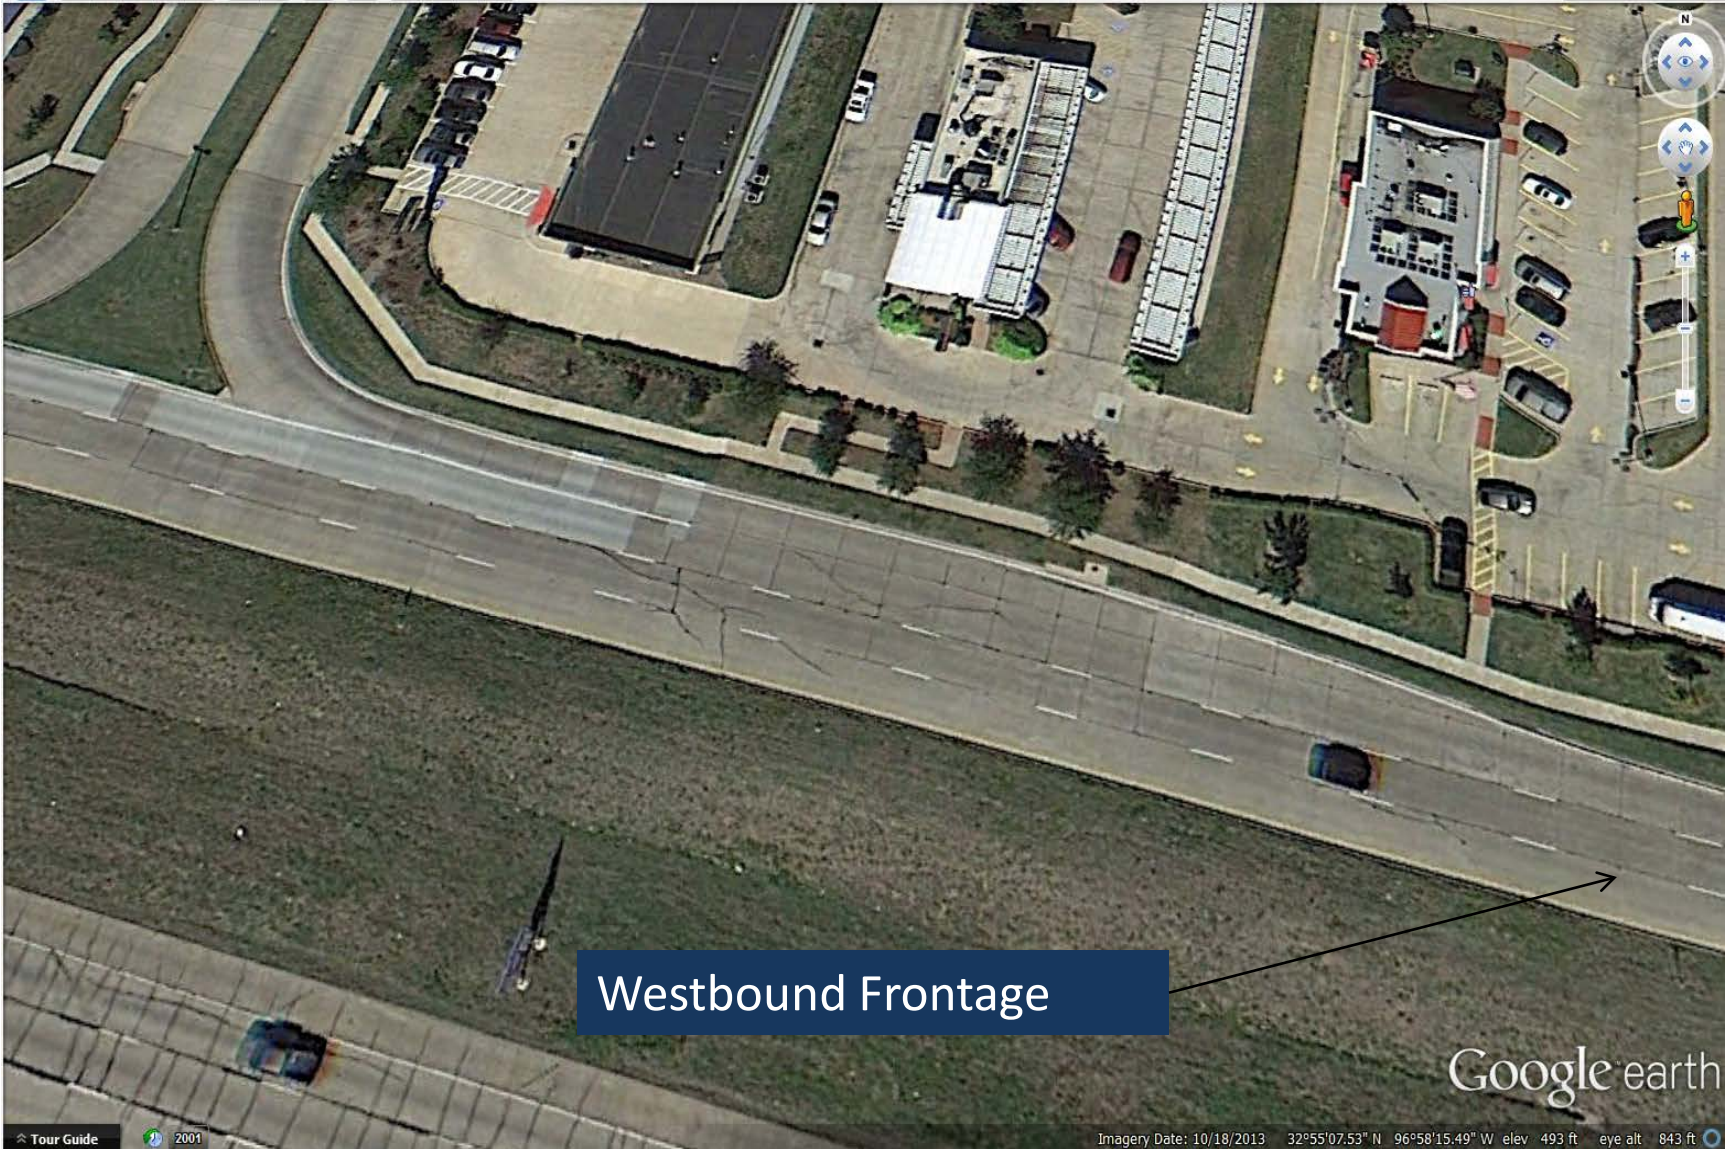
Four cracks extend outward from the edge of largest patch

Close-up of Westbound I-635 Frontage Road Damage
