NORTH COCKRELL HILL ROAD DAMAGE ASSESSMENT

Comparison of EMC SQUARED System Subgrade with Cement Stabilized Base

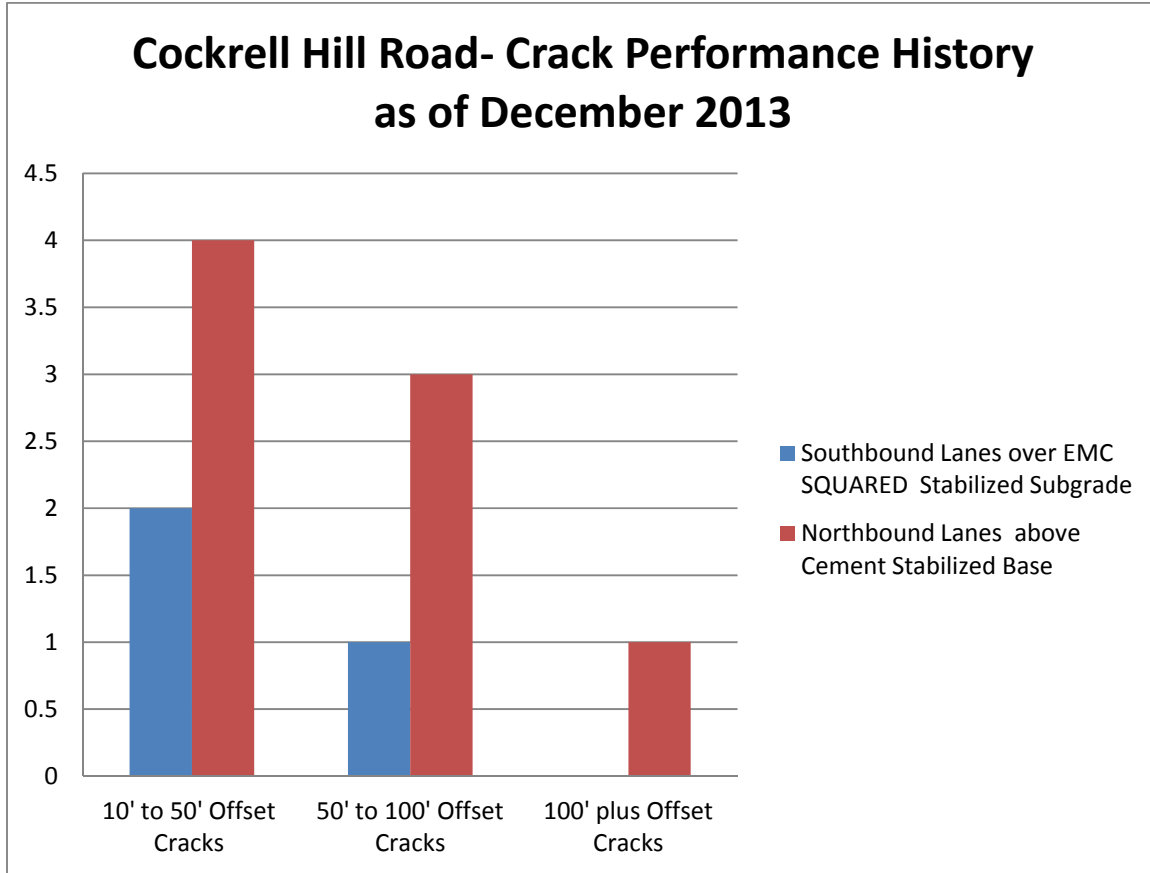
Structural Cracks – This type of damage was categorized into lengths and labeled as offset (vertical or horizontal movement). Refer to Chart A following.

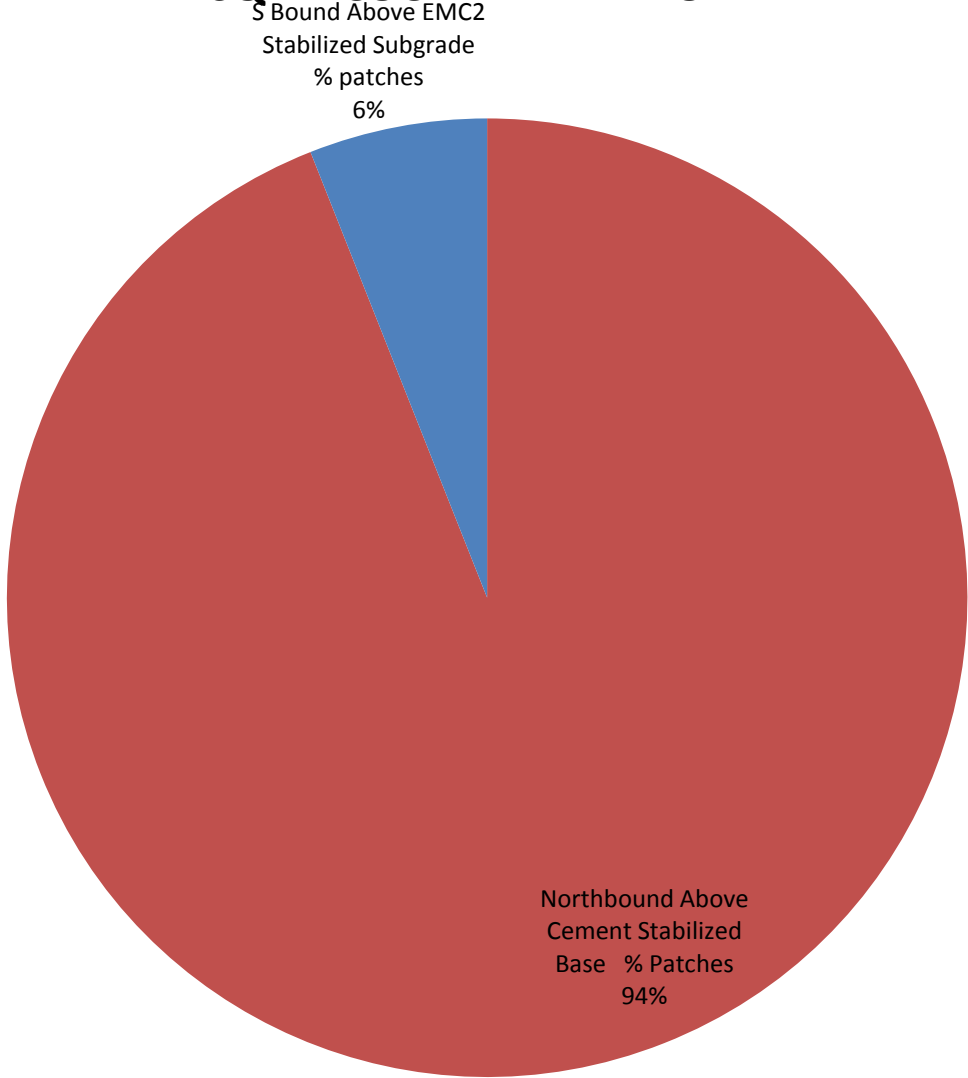
Chart B
COMPARING TOTAL AREA OF PATCH REPAIRS IN
SQ. FT. COCKRELL HILL ROAD

Concrete Patches – This damage type consists of areas that have been patched referencing photos provided by Bob Boykin. These areas have been categorized into square foot sized areas. Refer to Chart B following.

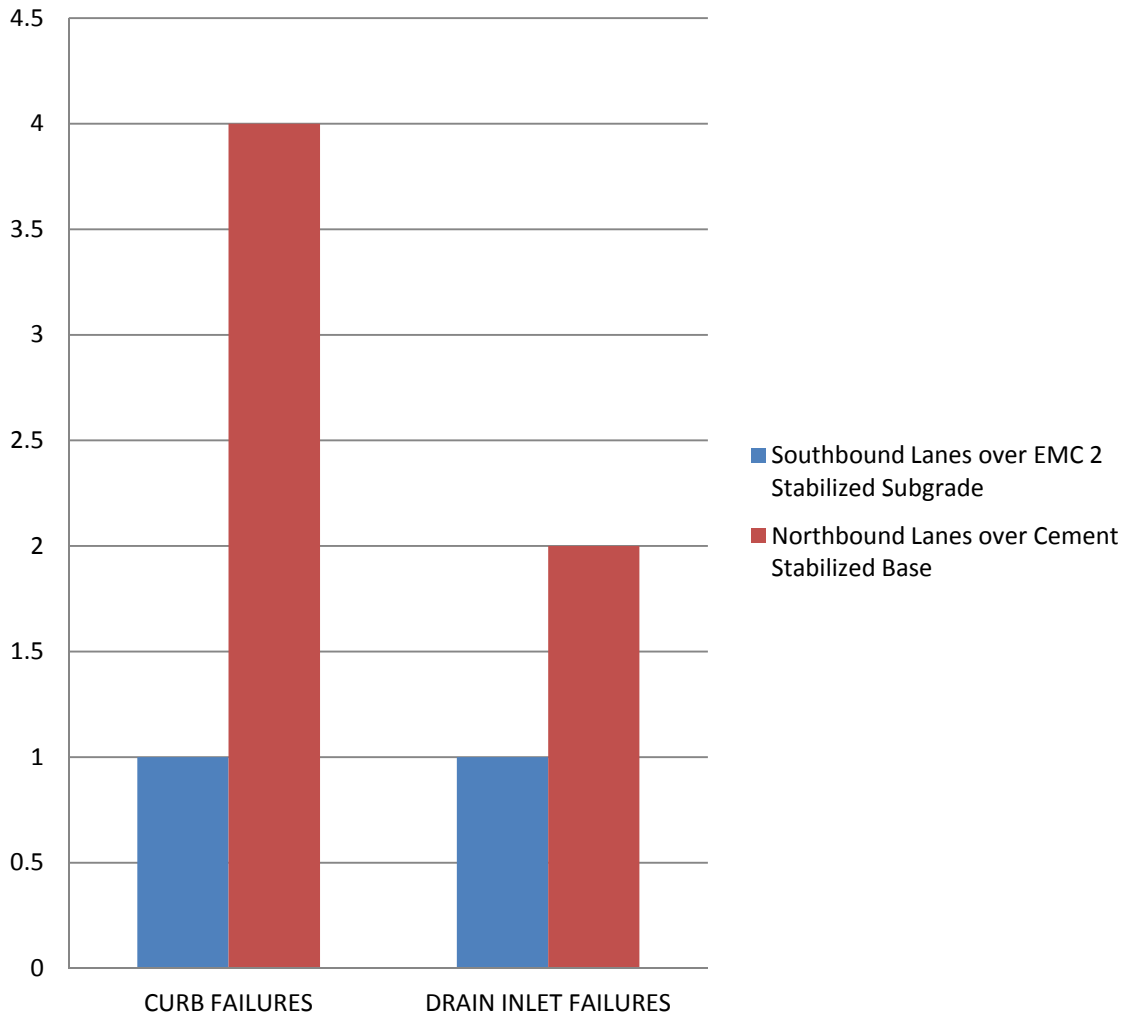
Chart C COCKRELL HILL ROAD CURB AND DRAIN INLET STRUCTURAL COMPARISON

Damaged Curb or Curb Drain Structures – This damage type were labeled as “c” or curb damage or “cd” as curb drainage structures. Some of these have been repaired. Refer to Chart C following.
