HEAD-TO-HEAD COMPARISON USING PAVEMENT DAMAGE ASSESSMENT DATA

EMC SQUARED SYSTEM STABILIZER PRODUCTS VERSUS CALCIUM-BASED STABILIZER PRODUCTS IH 635 EAST BOUND AND WEST BOUND FRONTAGE ROADS BETWEEN BELT LINE ROAD NORTH AND MACARTHUR BOULEVARD NORTH

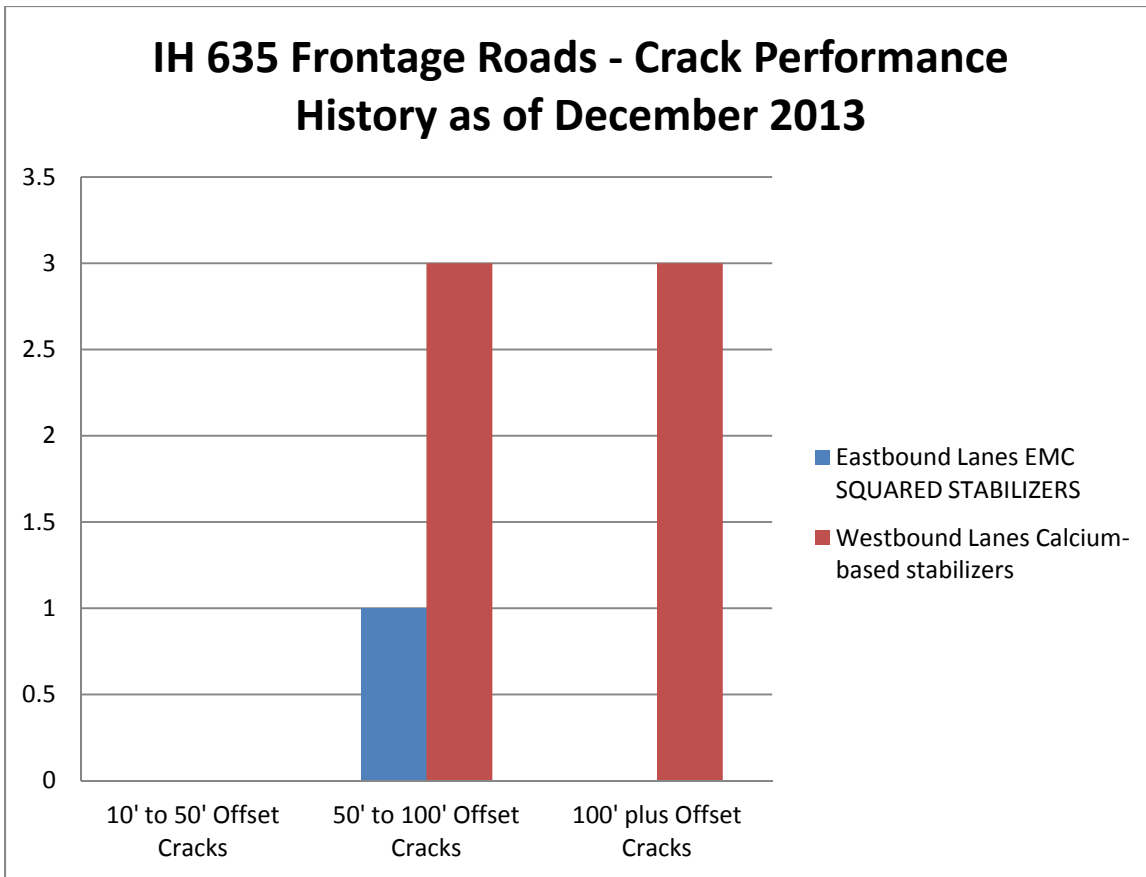
CRACK DAMAGE

| Eastbound Frontage Road EMC SQUARED System Products | | Westbound Frontage Road Calcium-based Products | |
|--|---|---|---|
| | 0 | | 3 (149', 267' & 878') |
| Total Cracks | 1 | | 6 |
| Total Offset | 1 | | 6 |

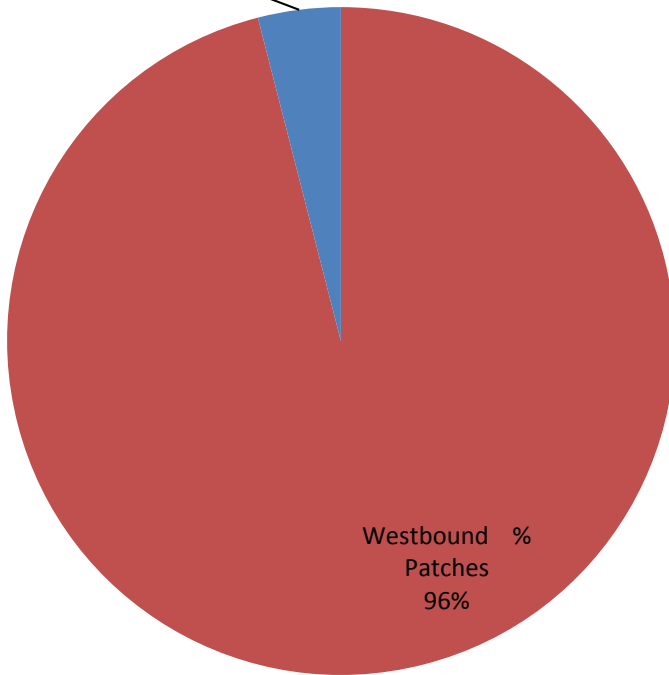
COMPARING TOTAL AREA OF PATCH REPAIRS IN SQ FT. IH 635 FRONTAGE ROADS

Eastbound
% Patches
4%

Westbound %
Patches
96%

3 total patches (occupying 70% of total length of frontage road)

All patches are >2000 sq. ft. in size (average of all three =12,740 sq. ft. in size)

Four cracks extend outward from the edge of largest patch

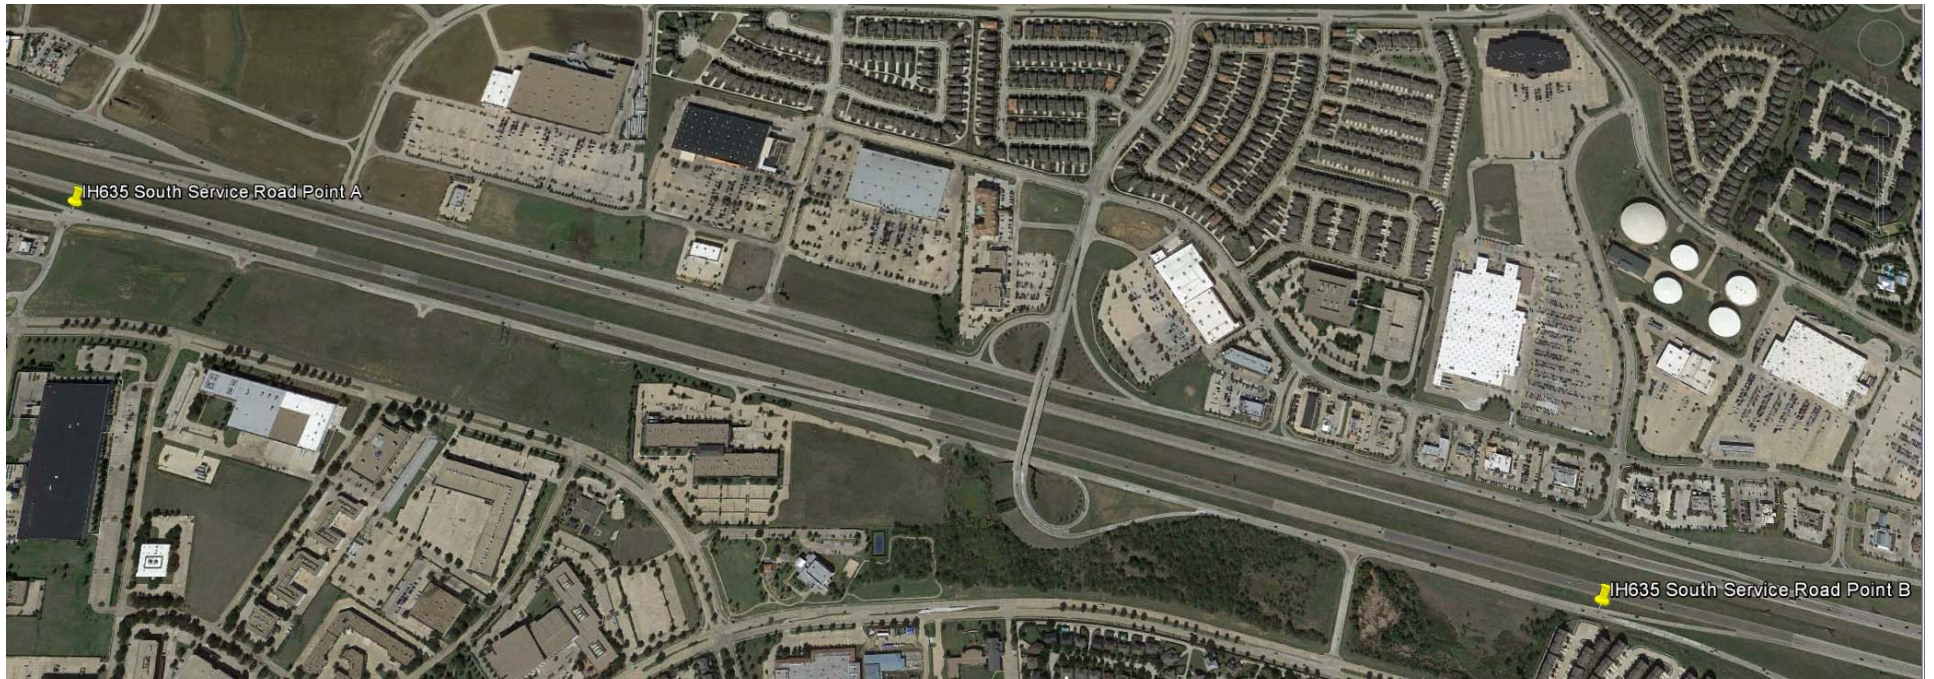
Point A

EMC SQUARED® Stabilization
IH635 South Service Road, Dallas, TX
